Surface Fatigue Life of High Temperature Gear Materials

Dennis P. Townsend
National Aeronautics and Space Administration
Lewis Research Center
Cleveland, Ohio

Prepared for the 30th Joint Propulsion Conference cosponsored by the AIAA, ASME, SAE, and ASEE Indianapolis, Indiana, June 27–29, 1994

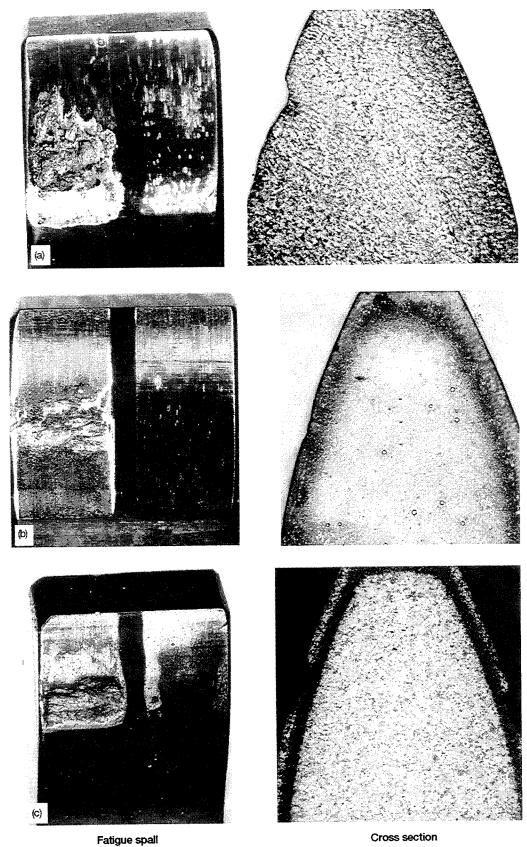
A Weibull plot of the surface-pitting fatigue life of the CVM VASCO max 350 gears is shown in Fig. 4(a). A typical fatigue spall is shown in Fig. 5(a). Several of the VASCO max 350 gears failed by tooth fracture either before or after a fatigue spall. A typical tooth fracture for these gears is shown in Fig. 6(a). The tooth fractures that failed after a fatigue spall were treated as surface fatigue failures while those that failed without a fatigue spall were treated as suspensions. There were two tests that ran for 500 hr without failure and these were also treated as suspensions. The 10- and 50-percent surface fatigue lives of the VASCO max 350 test gears are shown in the Weibull plot of Fig. 4(a) and Table 5 and was 2 million and 15 million stress cycles, respectively. These lives are considerably less than the standard AISI 9310 test gears which have a 10- and 50-percent surface fatigue of 20 million and 45 million

A Weibull plot of the surface pitting fatigue life of the VASCO matrix II gears is shown in Fig. 4(b). There were 33 fatigue tests run with this material, 11 of which ran for 500 hr without failure. A fatigue spall for this material is shown in Fig. 5(b). There were two gear tests that resulted in broken teeth for this material after running for some time with a fatigue spall. Figure 6(b) shows a typical tooth fracture through the fatigue spall for this material. The 10- and 50-percent surface fatigue lives of the VASCO matrix II test gears are shown in the Weibull plot in Fig. 4(b) and Table 5 and were 141 million and 287 million stress cycles, respectively. These lives were approximately 7 times the life of the standard AISI 9310 gears and more than 20 times the life of the VASCO max 350. The confidence number for the life difference between the VASCO matrix II and the AISI 9310 was 99 percent which indicates that the life difference is statistically significant.

The surface pitting fatigue life of the nitralloy N (AMS 6475D) is shown in the Weibull plot of Fig. 4(c). A typical fatigue for these gears is shown in Fig. 5(c). There were 23 surface fatigue tests conducted with the nitralloy N gears all of which resulted in surface fatigue spalls. The 10- and 50-percent surface fatigue lives of the nitralloy N are shown in the Weibull plot of Fig. 4(c) and Table 5 and was 19 million and 39 million stress cycles, respectively. The surface fatigue life of the nitralloy N was only slightly less than the life of the AISI 9310 and would be statistically equal to the life of the AISI 9310 gears. The confidence number for the life difference between the nitralloy N and AISI 9310 was 50 percent which means that the life difference is not statistically significant.

Figure 5.—Typical fatigue spall and cross section of three high temperature gear materials. (a) VASCO Max 350. (b) VASCO Matrix I. (c) Nitralloy N.

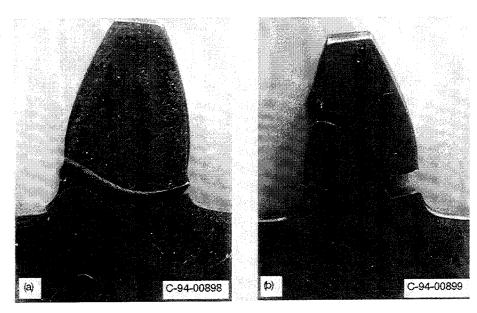
Figure 6.—Typical tooth fractures for two of the gear materials. (a) VASCO Max 350. (b) VASCO Matrix ${\rm I\! I}$.
